**NORTH SILVER LAKE DAM
MA 00307**

**PHASE I INSPECTION REPORT
NATIONAL DAM INSPECTION PROGRAM**

**DEPARTMENT OF THE ARMY
NEW ENGLAND DIVISION, CORPS OF ENGINEERS
WALTHAM, MASS. 02154**

AUGUST, 1980

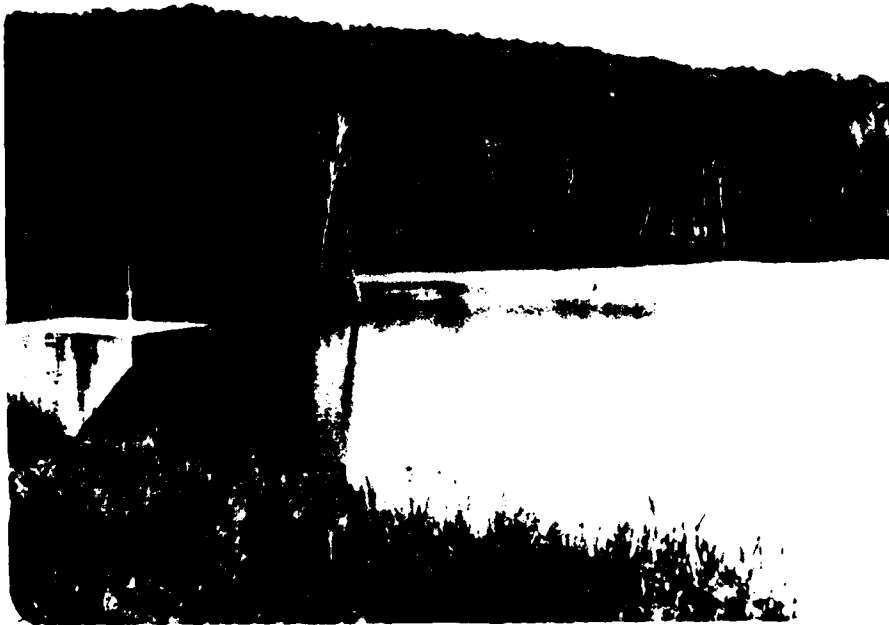
The principal spillway (see Appendix C, Photographs 4-6) is a drop inlet structure consisting of a two-stage reinforced concrete riser, discharging through a 48" diameter reinforced concrete conduit with rubber O-ring joints approximately 240 feet in length. The conduit is bedded on a concrete cradle set in ledge and has several reinforced concrete anti-seep collars. The riser has a height (floor to crest) of 60 feet and inside dimensions of 4 feet x 12 feet. The

Figure 4 - View of the reinforced concrete riser showing lower stage and upper stage trash racks.

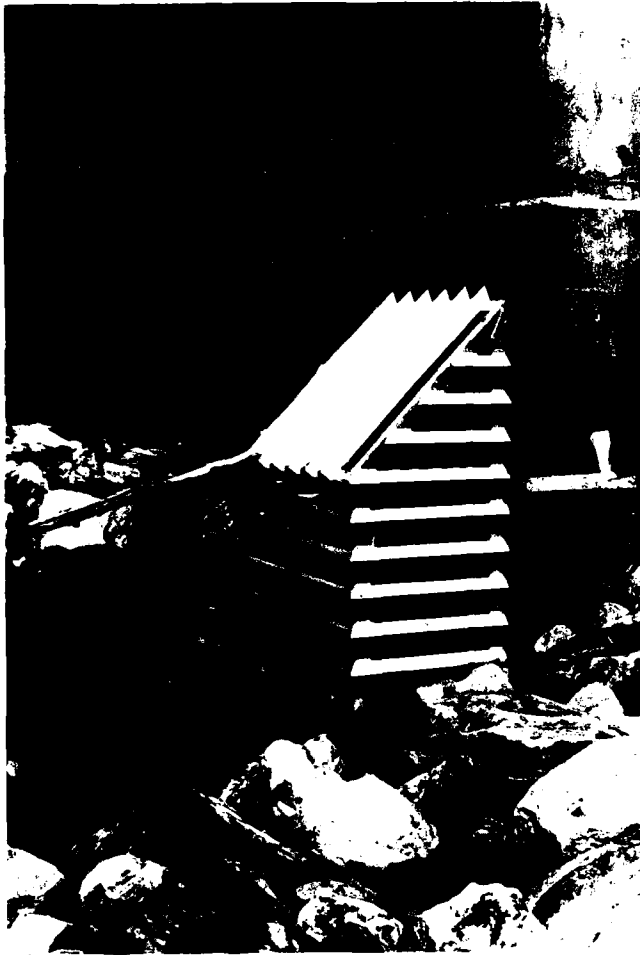
Figure 5

The concrete riser (principal spillway) is located to the right of the middle of the dam and is in generally good condition. (See Appendix C, photographs 5 & 6.) There is minor debris at the trash rack on the low stage riser orifice. The general condition of the principal spillway riser is good, with no spalling, rusting or staining of concrete apparent. Minor seepage, efflorescence and cracking was detected at the transition of the riser with the 48" outlet conduit. This condition is being monitored by SCS (see Section 6).

View of trash rack at upstream face of riser. Trash rack protects the 10" by 36" normal pool orifice (not visible).

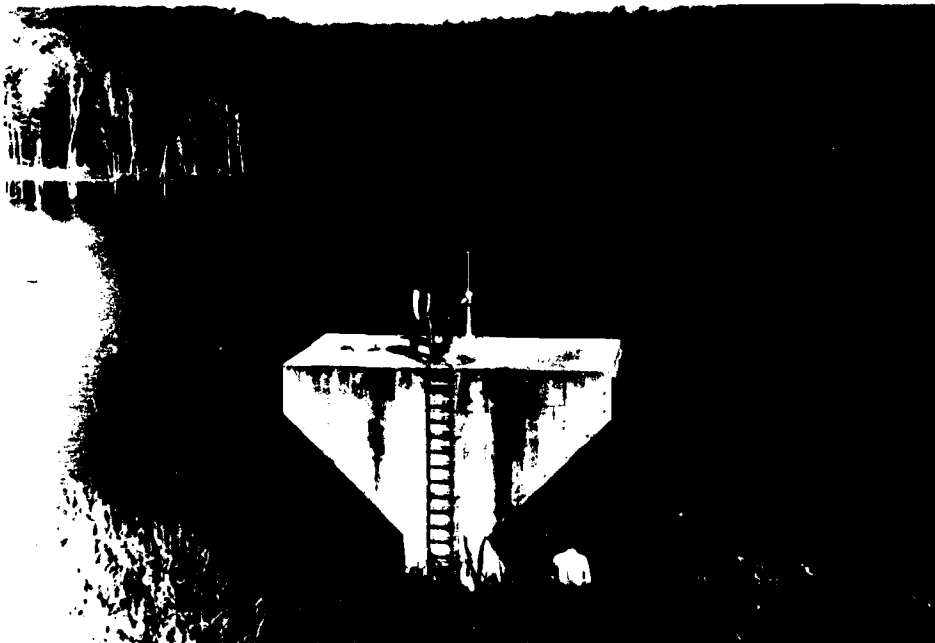
During the inspection the gate for the 24" reservoir drain was opened without difficulty. The gate would not seat tightly upon closure due to accumulation of rust in the operating mechanism. This condition has subsequently been remedied and the gate is operating satisfactorily. Routine cleaning and lubrication of the gate mechanism is necessary to prevent this condition from reoccurring.

Figure 6 - View of the downstream face of riser showing inspection manhole and gate operator with floor stand for the 24-inch reservoir drain.

The existing formal inspection and maintenance procedures including the technical inspection are good. The 24-inch reservoir drain sluice gate should be operated periodically to exercise the mechanism. Periodic lubrication and preventive maintenance of the mechanism should be carried out in accordance with the manufacturer's recommendations. The key for the gate operating handle should be secured to the operating shaft.

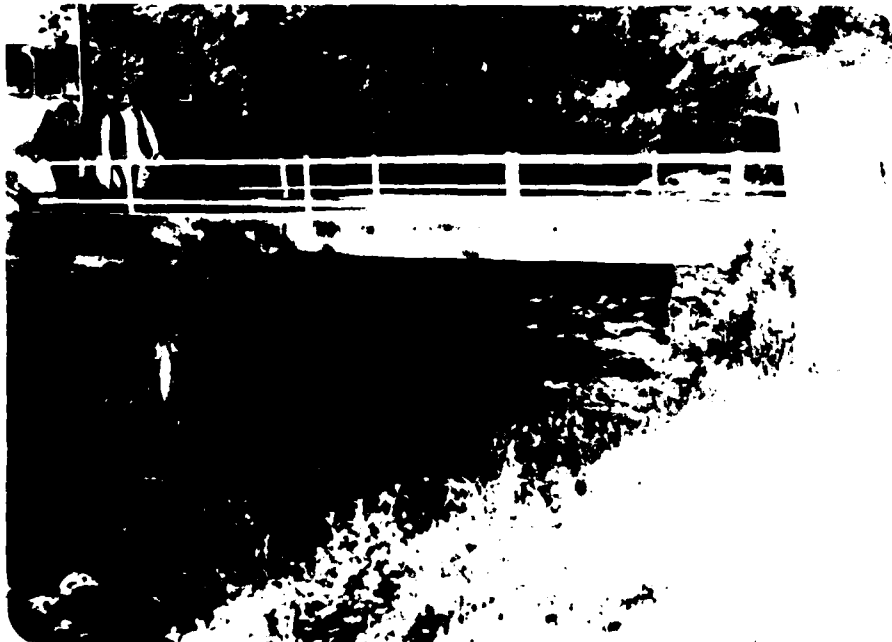
Neither the Back Road Bridge over Silver Brook (approximately 1 mile downstream from the dam) nor the Route 57 bridge over Silver Brook (approximately 1.7 miles downstream from the dam) have the capability of passing the attenuated breach flow of 397,000 cfs. Approximately 10 residences in West New Boston could be damaged or destroyed by the breach flood-wave which would have an estimated height of 20 feet at this location. Prior to the breach, water would be just flowing over Route 57 and two to three residences would potentially be flooded at depths estimated to be in the order of 2 feet. The breach flow would flood approximately 10 residences at depths ranging from 2 to 10 feet. Appreciable property damage and loss of more than a few lives under breach conditions would be likely. Therefore, North Silver Dam has been classified as High Hazard.

Figure 14 - View of bridge opening (looking upstream) at Route 57 in the village of West New Boston about 7700 feet downstream of damsite. Note structures in close proximity to the brook.
